Service Bulletin

AMERICAN HONDA MOTOR CO., INC.

1997- 98 GL1500C/CT VALKYRIE Hondaline® CB Radio Kit

(This supersedes GL1500 #8, dated June, 1998)

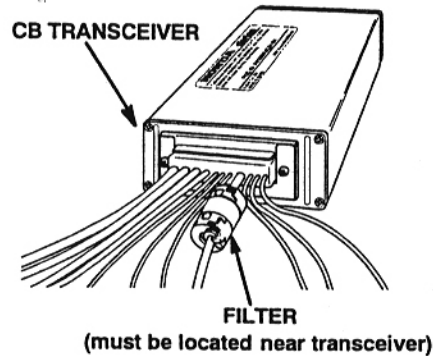
TRANSCEIVER IDENTIFICATION

The new transceiver can be identified by the noise suppression filter attached to the 7-pin (black) DIN connector. There are other internal changes to the transceiver which are not visible. **IMPORTANT:** The noise suppression filter must be near the transceiver to work properly.
